Optimal Allocation of Land for Training and Non-training Uses (OPAL)

Initial Effects of Heavy Vehicle Trafficking on Vegetated Soils

August 2012

Final report

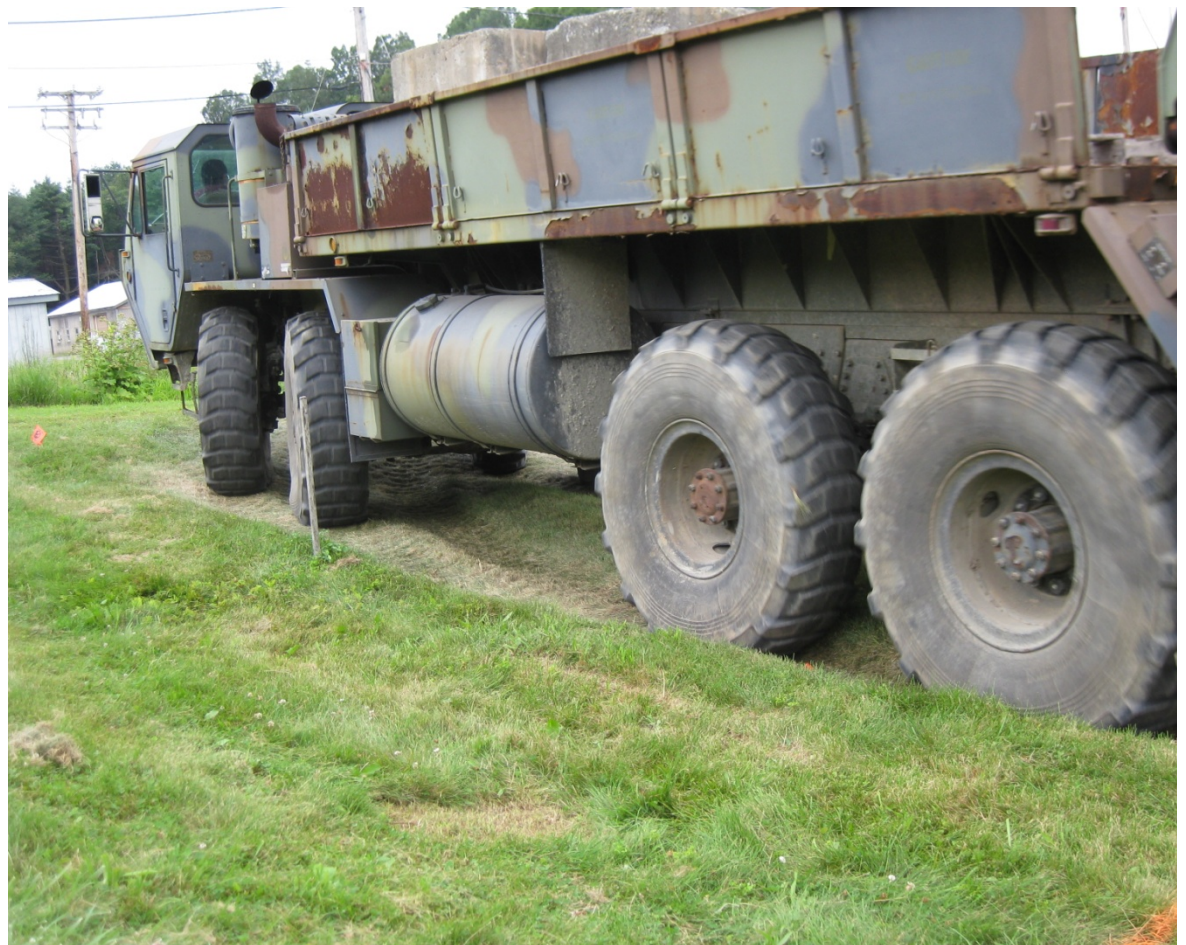
Front Cover: Rut formation due to heavy vehicle trafficking of the outdoor loam test section.

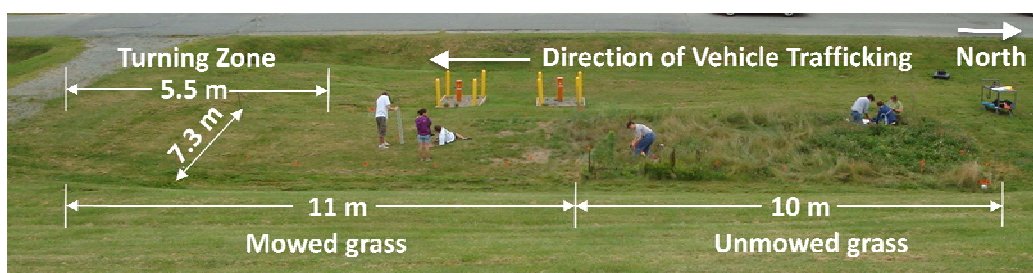
Figure 1. Outdoor test section. Test vehicle travels straight from North (right) to South across two treatments, mowed and unmowed grass, then turns in the last 5.5 m of the test section.

The outdoor section was underlain by Loamy Sand soil, consisting of a poorly graded medium to fine sand with silt. The section had two treatments: mowed grass and unmowed grass. Its vegetative cover was Perennial Rye grass mixed primarily with Clover. The section had been vegetated several years prior to trafficking and was thus well established. The test section is 7.3 m wide and 21 m long, with 10 m of unmowed grass and 11 m of mowed grass for treatments (Fig. 1). Grass in the unmowed section reached a height of approximately 0.5 m. The test vehicle was driven straight through the section except for the last 5.5 m of the mowed grass treatment, which was the turning zone, also referred to as the shear zone.

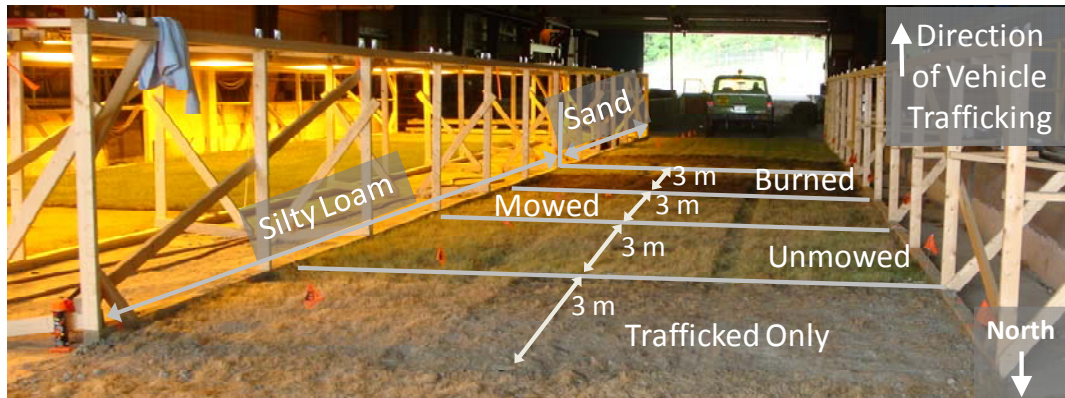
Figure 2. View of FERF test section. Test vehicle travels from North (foreground) to South across eight 3-m test sections: trafficked only, and unmowed, mowed, and burned grass in two soil types: silty loam and sand. Vehicle shown is the CRREL Instrumented Vehicle.

Test sections for this study were constructed on the west side of the FERF over a two-month period and allowed to mature over four months. Other test sections were also constructed on the east side that were intended for use in a separate study. Artificial growing conditions were simulated in the FERF through temperature control, growth lights, and twice-weekly watering. The 4.5-m wide by 24.4-m long test section is split into two equal halves by soil type: a poorly graded sand with silt and a clay-rich silty loam. To replicate a natural field setting, the test section soils were minimally compacted when installed. The test section was planted with Perennial Rye grass and divided into four treatments (each 3 m in length) within each soil type: trafficked only (no vegetation), unmowed grass, mowed grass, and burned grass (Fig. 2). A 1-m transition zone separated the loam and sand soils. Grass in the unmowed treatment areas reached a height of approximately 15 cm. Shoop et al. (2010) describe additional details on the test sections' construction. The trafficked-only section was originally intended to be bare soil, but grass grew in that section. To remedy this, grass in the trafficked-only section was treated with glyphosate and raked prior

to the experiments. The test vehicle traveled from North to South, crossing the silty loam test section first before transitioning to the sand soil test section.

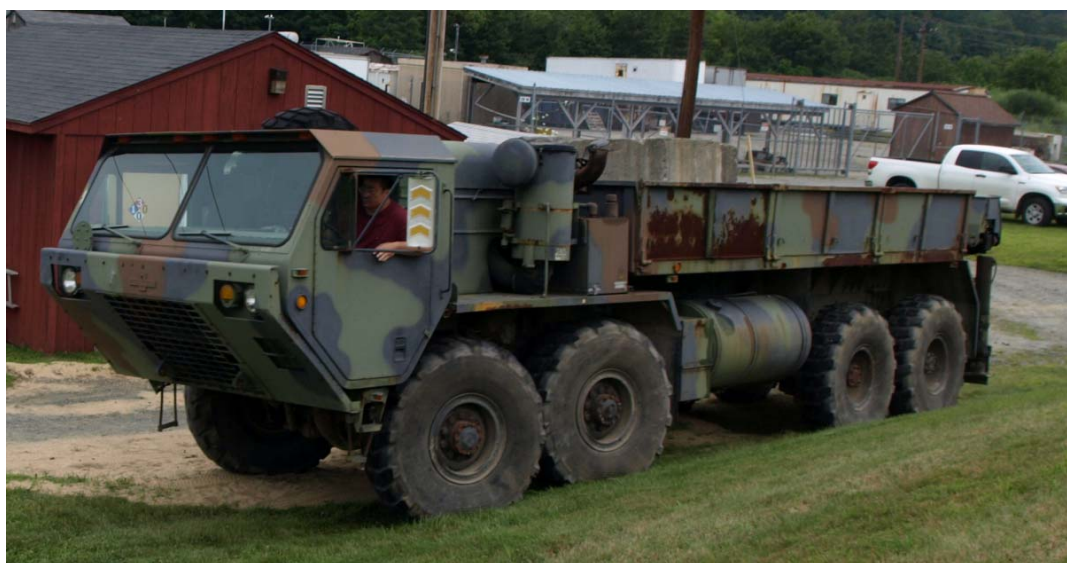
Figure 3. Heavy Expandable Mobility Tactical Truck (HEMTT). This 8 x 8 vehicle is steered with the two front axles with a total vehicle weight of 23,000 kg including payload.

The primary vehicle trafficking was conducted with a large off-road military vehicle known as a Heavy Expanded Mobility Tactical Truck (HEMTT 977). The HEMTT is an 8×8 vehicle with a 61-cm (24-in.) ground clearance that is steered with the front two axles (Fig. 3). The gross vehicle weight of this HEMTT was 18,257 kg (40, 250 lb) and it was loaded with an additional 4717 kg (10,400 lb) payload. The 16.00R \times 20 tires were run at the pressure specified for cross-country operations: 241 kPa (35 psi) on the two front axles and 276 kPa (40 psi) on the two rear axles.

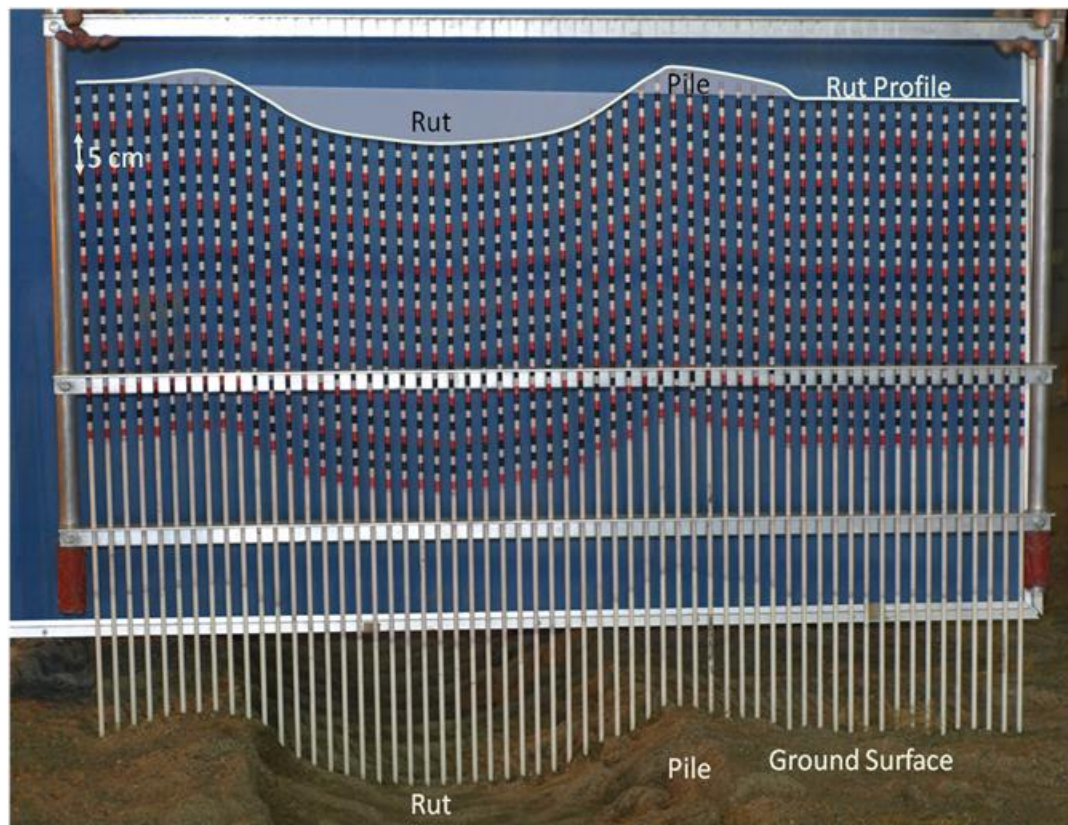
Figure 4. Profilometer used to measure the disturbance profile. The device documents maximum rut depth and pile height in centimeters for each sampling location.

Vehicle rut and disturbance profiles provide an easy measurement of terrain disturbance due to vehicle trafficking. Terrain disturbance was assessed by determining the maximum rut depth and pile height. Rut profiles were obtained using a profilometer, which consists of a 1.25-m metal frame holding 59 fiberglass rods spaced every 2 cm horizontally and marked every 1 cm vertically (Fig. 4). To collect measurements, the profilometer is carefully centered in the rut such that the rods are touching the soil surface. An image of the profilometer is then acquired showing the profile of the rut. The images are processed in the program MATLAB^{®1} using a script (Appendix A) that allows the user to quickly trace the rut profile and outputs the maximum rut depth and pile height in engineering units. The rut depth and pile height provide a reasonable indication of the impact severity.

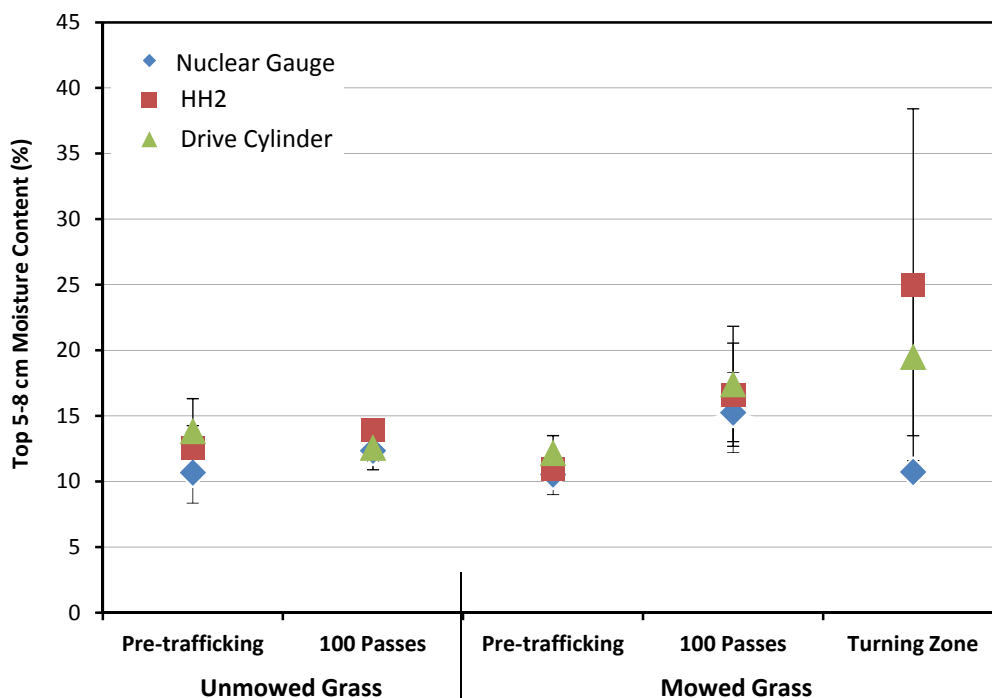
Figure 5. Near-surface volumetric moisture content measured by three sampling techniques in the outdoor test section. Error bars indicate one standard deviation.

An analysis of the soil moisture measurements collected with the three sampling techniques [nuclear gauge; capacitance-based probe (HH2); drive cylinder] shows they provide similar values. This is demonstrated in Figure 5, which presents data from the near-surface (top 5–8 cm) using all three techniques taken at the outdoor test section before and after trafficking. Given the similarity in results, the nuclear gauge was chosen as the preferred method for obtaining soil moisture measurements as it provides readings at multiple depths and simultaneously measures dry density data. Figure 5 also shows the difference in average volumetric moisture content for each area before and after trafficking. In the unmowed grass section, moisture content did not change significantly; in the mowed grass section, however, moisture content increased after trafficking. Given the variability of the data in the turning (shear) zone, it is difficult to assess the impact of trafficking on the soil moisture content in that section.

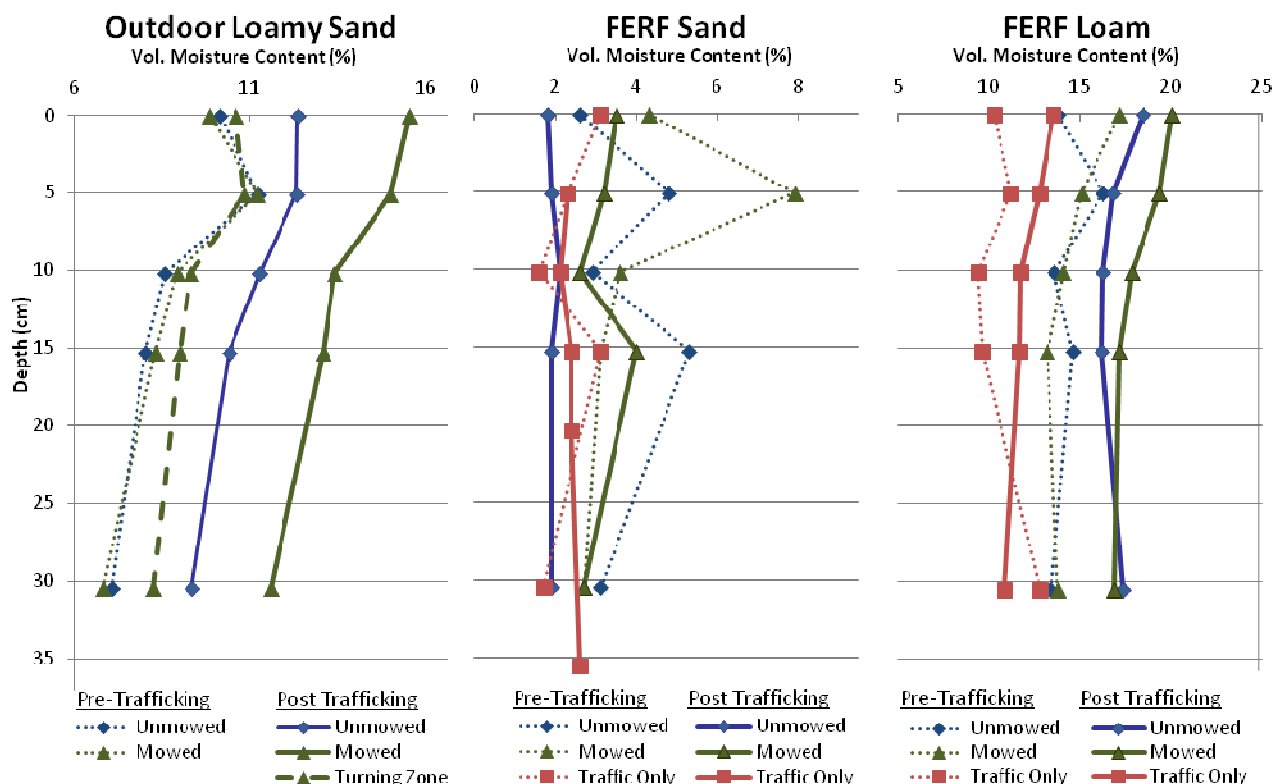
Figure 6. Moisture contents of test soils prior to trafficking (dotted lines) and post-trafficking (solid and dashed lines). Moisture contents increase with trafficking in the loamy soils both outdoors and in the FERF; the FERF sand soil loses moisture with trafficking.

Moisture contents at depth for the outdoor loamy sand and FERF silty loam soils increased with trafficking; on the other hand, moisture content decreased after trafficking in the FERF sand soil (Fig. 6). The slight decrease in moisture content for the sand may be due to the time delay (approximately 24 hours) between the initial and the post trafficking measurements. The decrease may also be due to evaporation or to a combination of the two factors. The moisture content increase in the outdoor loamy sand and FERF loam is likely due to the soil retaining its moisture while being compacted; the apparent moisture content percent increases with compaction, but the weight of water in the soil remains the same. The increase in moisture content of the mowed grass treatments in the outdoor loamy sand and FERF silty loam was greater than the unmowed grass treatments. In the FERF sand, the mowed grass treatment had a greater decrease in moisture content near the surface (5 cm) than the unmowed grass. Overall, soil conditions in the mowed grass treatments were impacted more than in the unmowed grass treatments.

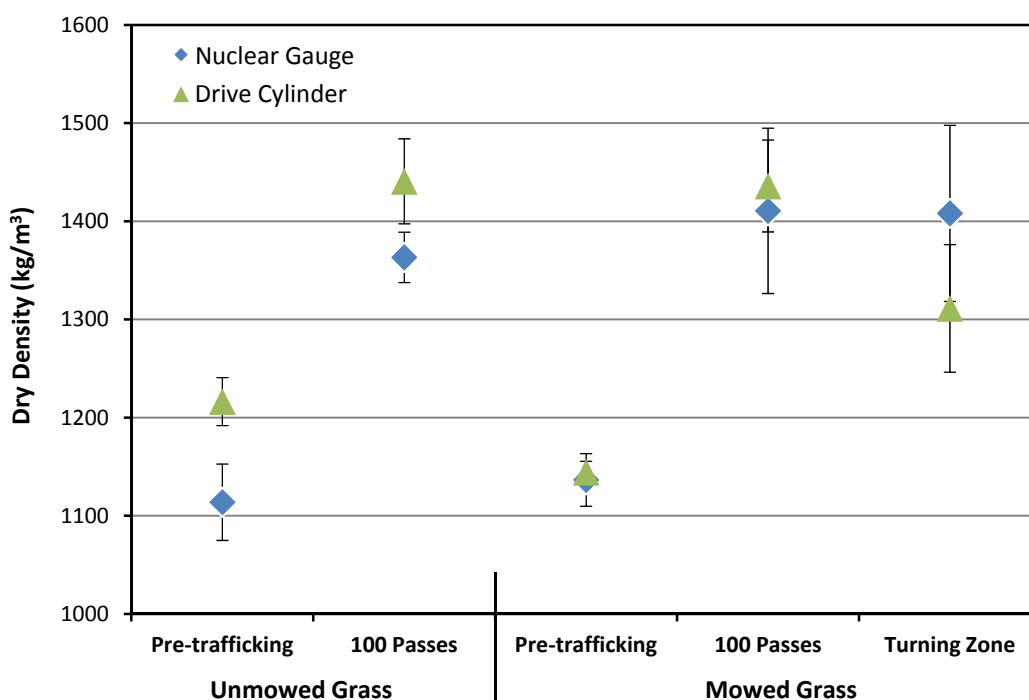
Figure 7. Comparison of dry density measurements using nuclear gauge and drive cylinder techniques at the surface for the outdoor test section.

On average, dry density measured using the drive cylinders was 2% higher than that measured using the nuclear gauge. However, since the nuclear gauge also provides moisture content data, only the nuclear gauge was used for measurements in the indoor section. In the near surface (top 0–6 cm) of the outdoor section, trafficking increased the dry density by approximately 20% in the unmowed grass section and 25% in the mowed grass section (Fig. 7). Data in the shear section (turning zone) is more variable; there the dry density increase ranged between 15 and 24%.

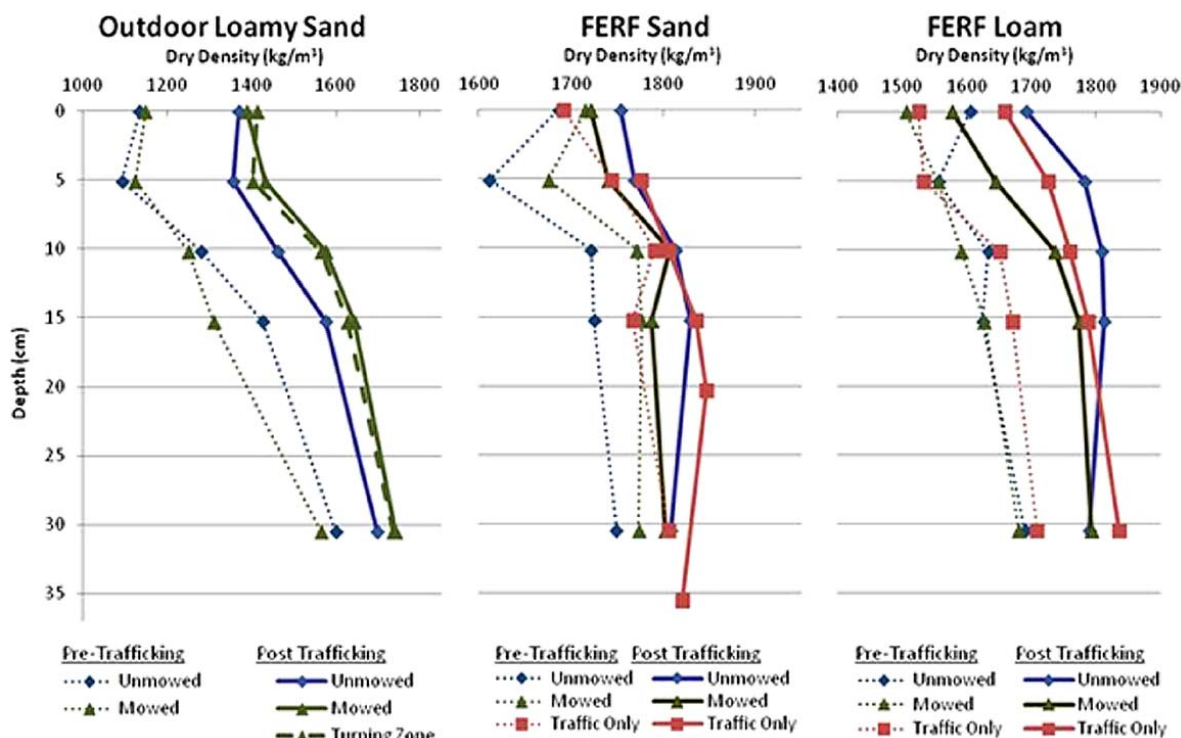
Figure 8. Dry density versus depth for all test sections and treatments. In all cases, density increases after trafficking.

For all test sections, trafficking, and thus soil compaction, increases the dry density of the soil both at the surface and at depth as shown by the results of the nuclear moisture/density gauge (Fig. 8). Density increase is most significant at the surface, but continues to a depth greater than 30 cm. The density increase was greater in outdoor loamy sand and FERF silty loam soils than in the FERF sand soil. In the outdoor section, soil density in the mowed grass increased more than in the unmowed grass. The opposite was the case in the FERF for both the sand and loam soil types. This difference could be related to how long the grass treatments had been established. The unmowed grass of the outdoor section provided

a mat that the vehicle drove across and little soil was exposed. The unmowed grass of the indoor loam section was shorter and not as thick, allowing the soil to be exposed more readily to the vehicle tires. A future biomass analysis from these experiments will provide additional insight.

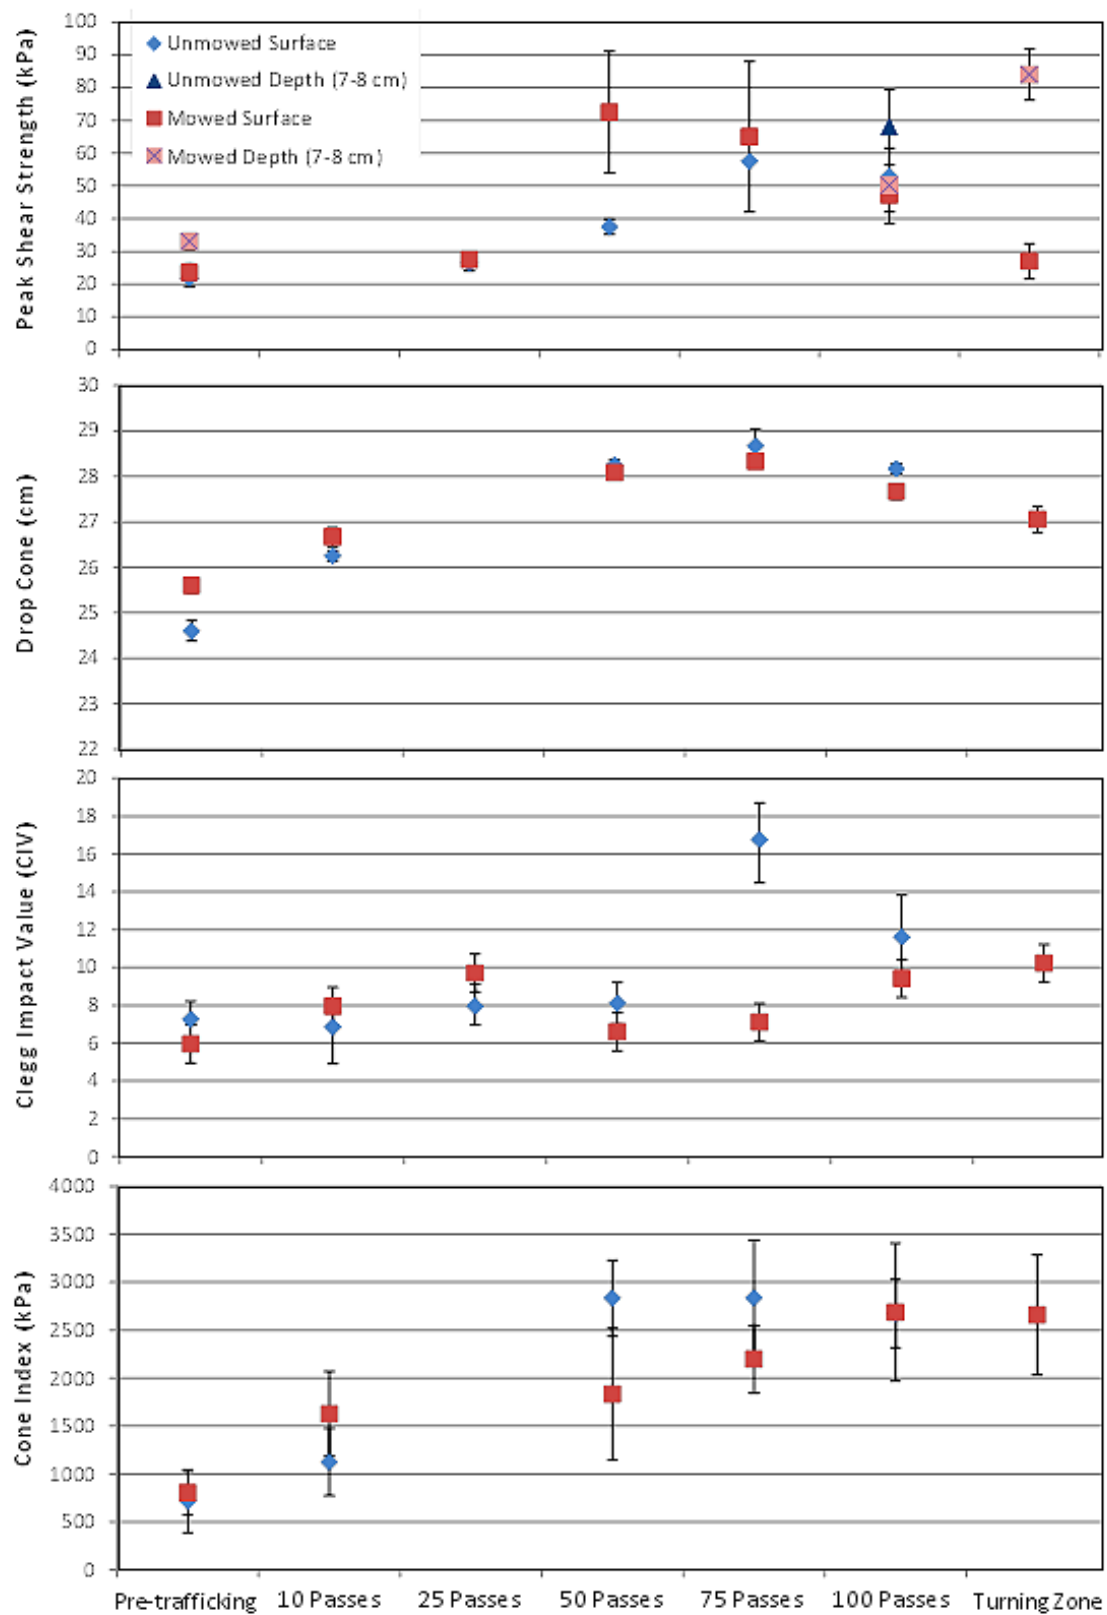
Figure 9. Strength indices for outdoor loamy sand. Data shown for the turning zone were measured after 100 passes.

As expected, heavy-vehicle trafficking increased soil strength in all test sections (Fig. 9). Cone index results show an increase in soil strength in the upper 15 cm with increasing vehicle traffic. Soil strength as measured by dynamic drop cone also increases for both treatments (mowed, unmowed) up to a peak around 75 passes, followed by a decrease at 100 passes. Soil strength in the turning zone, where the tires apply a greater shearing force, is lower than in the mowed grass straight section after 100 passes. The surface soil strength of the unmowed treatment increased more steeply than the mowed grass and remained slightly higher after 100 passes. The increases in soil strength are likely due to compaction. Decrease in near-surface soil strength at or near the end of testing may result from tire lugs breaking up the soil surface, including the root structure.

Similar to soil strength, shear strength initially increases substantially with trafficking, then decreases with additional trafficking as the soils become more deformed and vegetation is significantly impacted. As seen in the upper graph of Figure 9, shear strength in the mowed grass treatment increases dramatically between 25 and 50 passes, then decreases with additional passes. In the unmowed grass treatment, it increases more slowly, peaks at 75 passes, and then decreases. Surface shear strength in the turning zone after 100 passes is similar to the pre-trafficking shear strength. The shear strength at depth increases substantially after 100 passes and most dramatically in the turning zone where the soil is exposed to combined vertical and shear loading. Similar to the strength indices, the shear strength increases are likely due to compaction, and as the sections become significantly impacted at the surface by tire lugs, shear strength decreases.

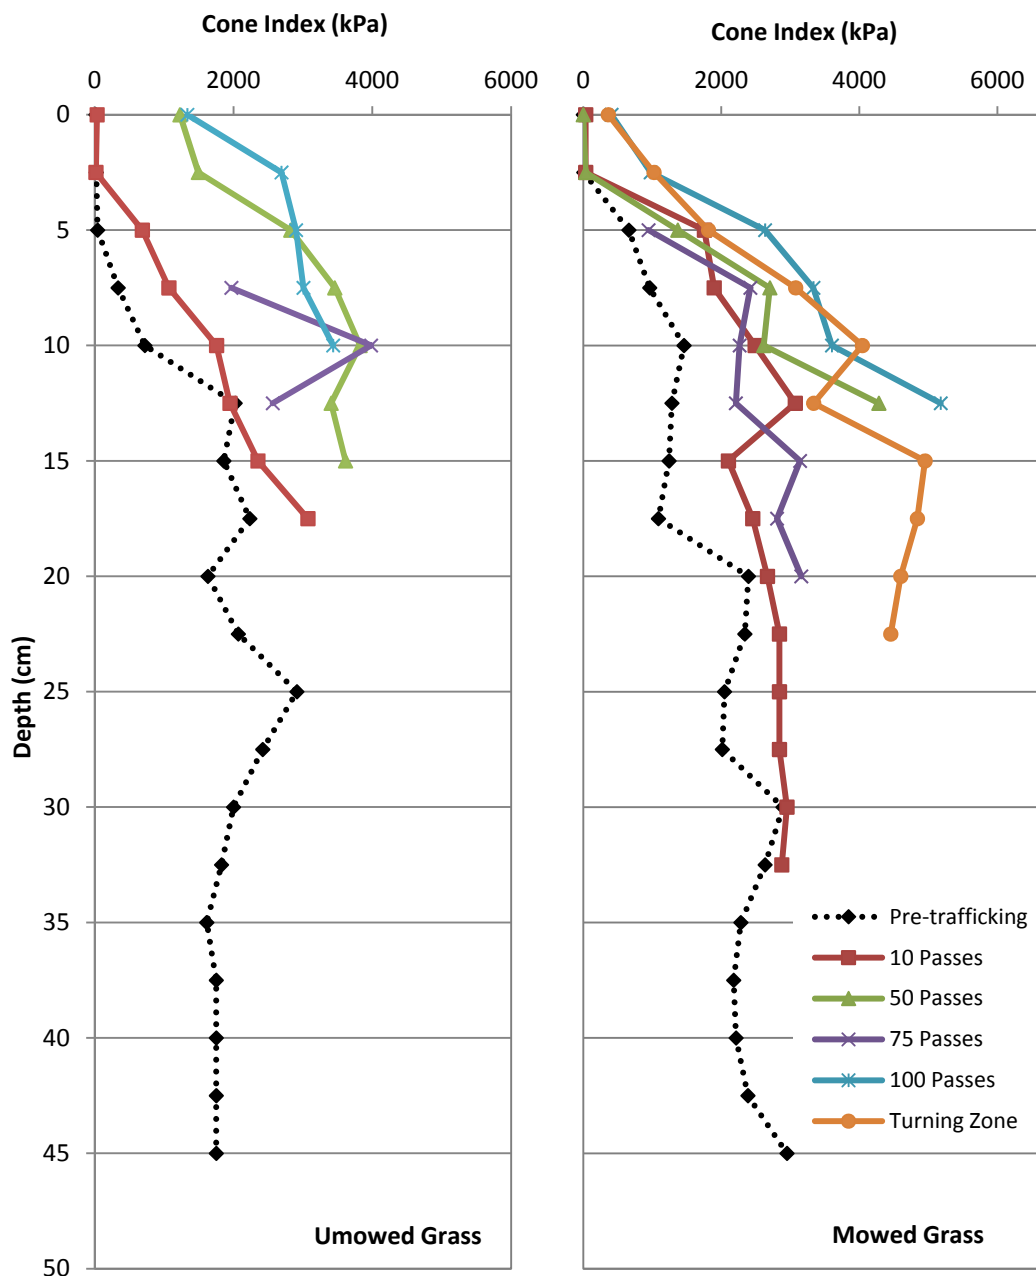
Figure 10. Cone index soil strength profiles for the outdoor unmowed (left) and mowed test sections (data presented are the averages of all readings in the section at that number of passes).

Cone index measurements taken at depth show that soil strengthening continues to the maximum depth measured by the cone penetrometer (Fig. 10). The profiles end when the cone penetrometer could no longer be pushed into the soil. Soil strength in the mowed grass section is higher at depth than in the unmowed section. However, surface soil strength of the unmowed section increases more substantially after 50 passes than in the mowed section.

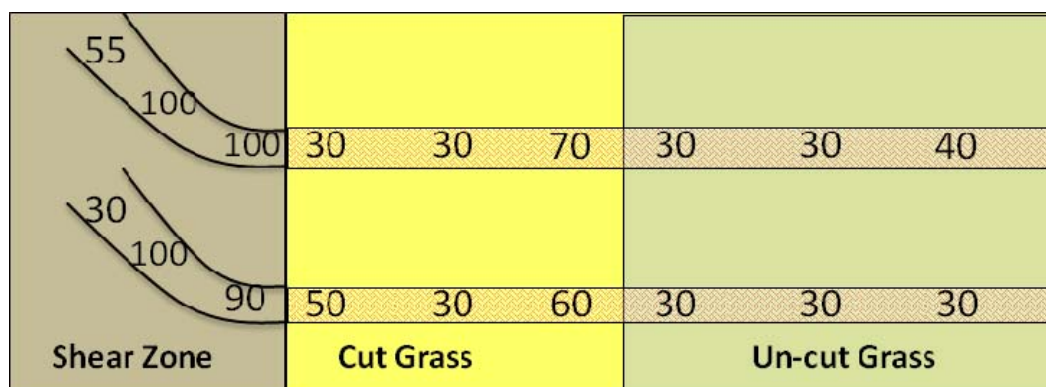
Figure 13. Outdoor section impact severity index results.

The impact severity based on the guidelines in Table 4 was measured after trafficking the outdoor section (Fig. 13). Trafficking had little impact on vegetation in the unmowed grass section; thus, the impact would be classified as imprint and pile according to Haugen et al. (2002). The impact was more severe in the mowed grass section, with a pile and combined classification between imprint and scrape. Trafficking impact was most severe in the shear (turning) zone. The impact severity categories mirror the decrease in drop cone index and shear strength observed in the mowed section and shear zone. The less severe ratings in the unmowed section also compare well with the lower decrease in drop cone indices and shear strength measured in that section.

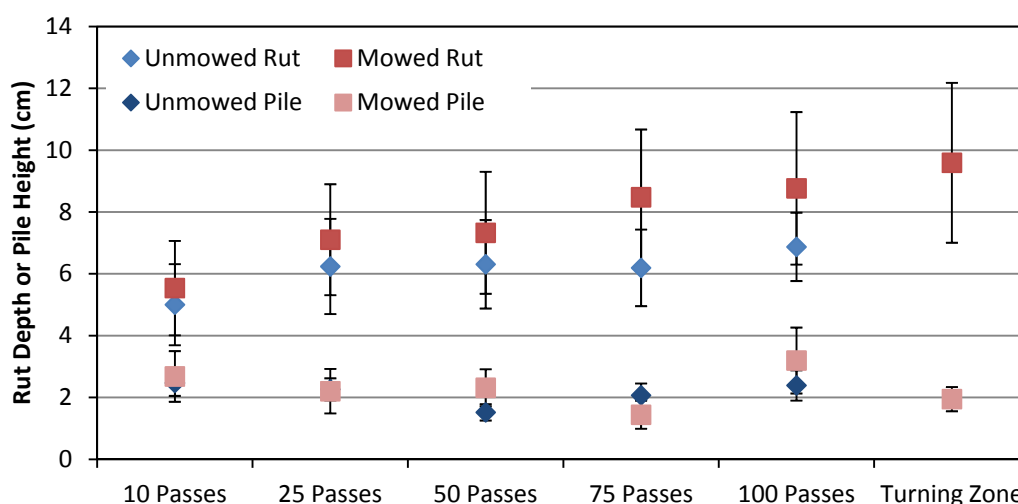
Figure 14. Outdoor loam rut depths and pile heights. Turning zone data were collected at 100 passes.

Rut depths in the outdoor loam test section were highest for the mowed grass treatment reaching an average maximum depth of 9 cm with an average maximum pile height of 3 cm after 100 passes in the straight trafficking section (Fig. 14). Rut depths in the mowed grass straight trafficking section were on average 2 cm deeper than in the unmowed grass section. Rut depths in the turning zone were slightly higher than the straight section. Rut depths increased substantially from the first pass to 25 passes then increased much more gradually as the soil density and strength increased.
